Engineering Geological Characterisation and Slope Stability Assessment of Whitehall Quarry, Waikato.

Master of Science in Engineering Geology

University of Canterbury

2010

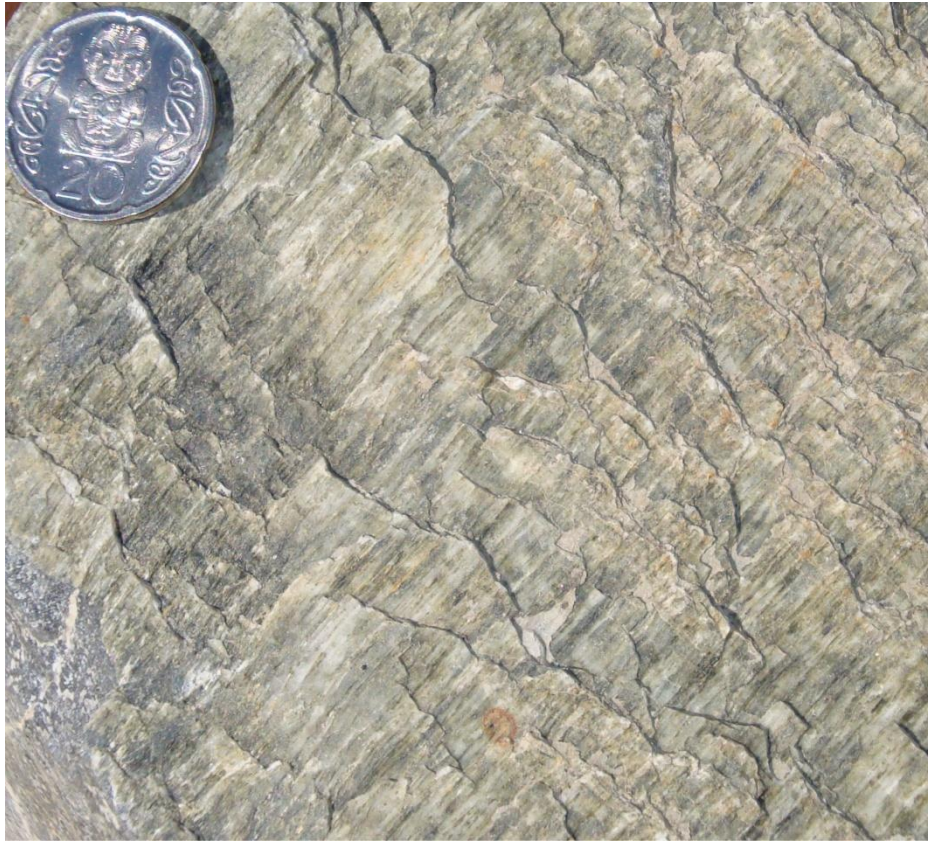
Figure 1-6: Fibre growths on fault planes indicating normal sense of movement.

Tonkin & Taylor Ltd (2008) noted many major (greater than 30 m) and minor (less than 30 m) faults within Whitehall Quarry. Some surfaces within the fault zone exhibit well developed stepped striations indicating a normal sense of movement for at least the last phase of movement (Figure 1-6).

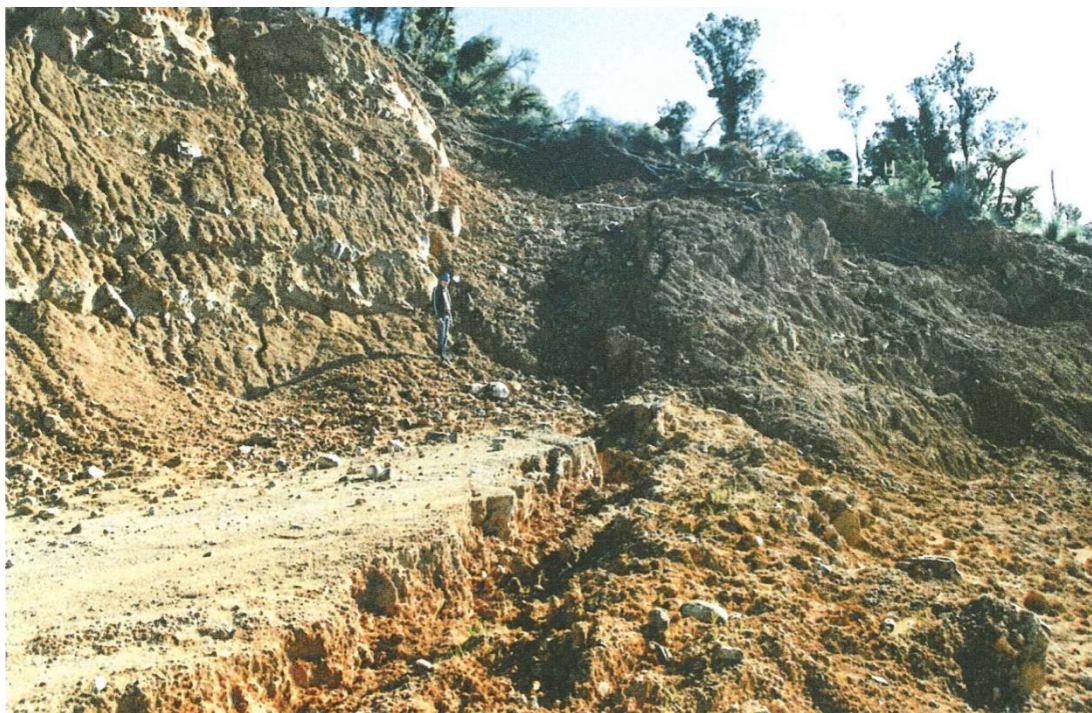
Figure F-6: Tensions cracks soon after wedge failure initiation (Hancock Consultants Ltd, 1989).

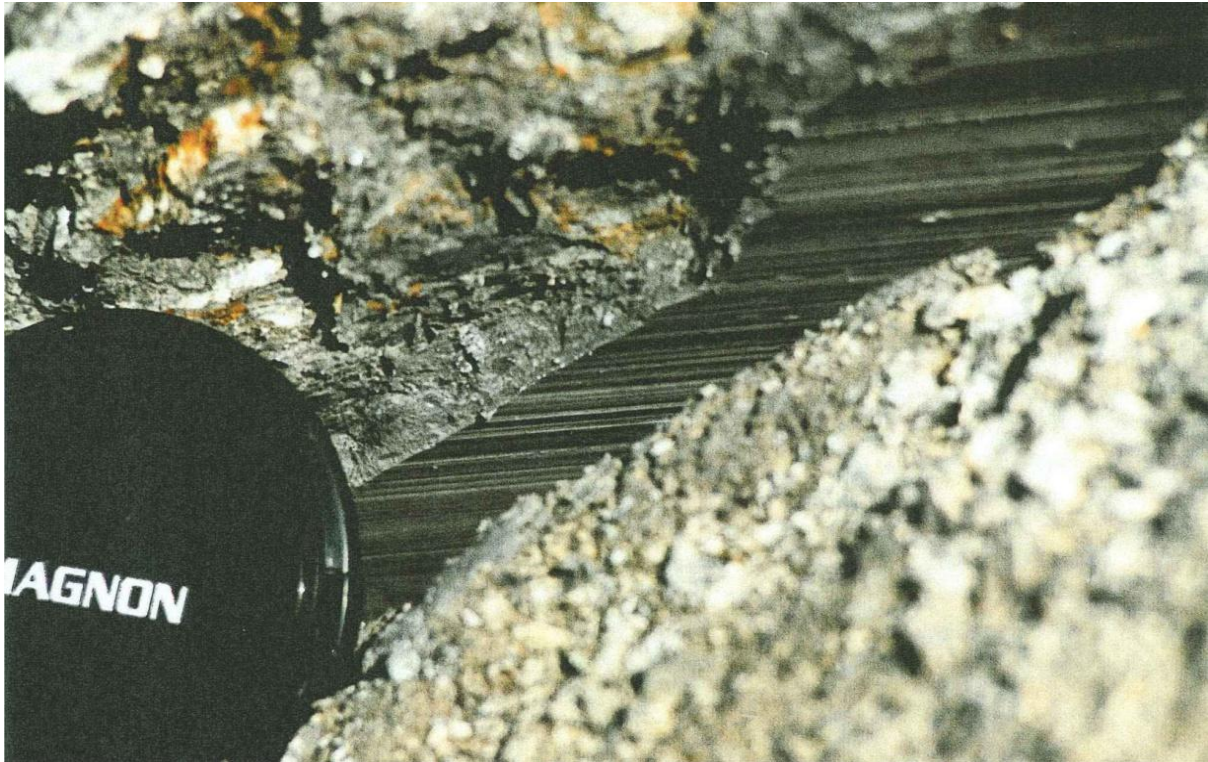
Figure F-8: Fault gouge on Plane B of Northern Wedge Failure (Hancock Consultants Ltd, 1989).
